# *Datwyler Inspection Service's LLC*

## Property Inspection Report

1946 664th Ave, Albia IA, 52531  
Inspection prepared for: Kirk Datwyler  
Inspection Date: 2/23/2010 Time: 1400  
Age: 10 years Size: 2500 sq ft  
Weather: sunshine, 6" snow covering

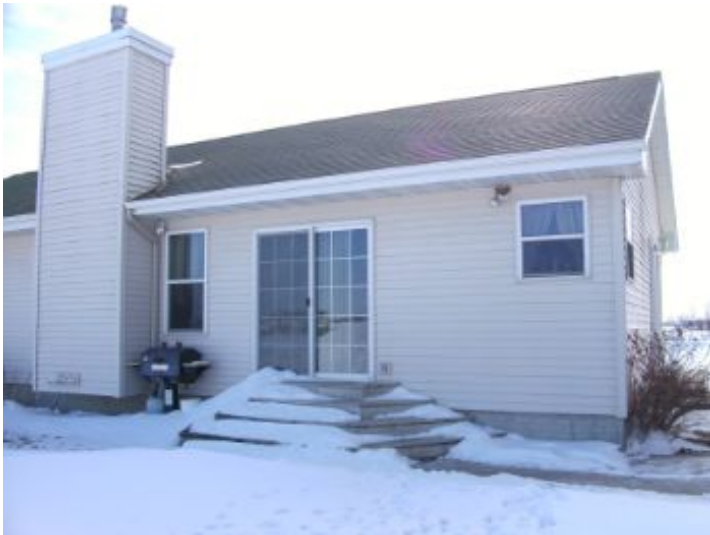
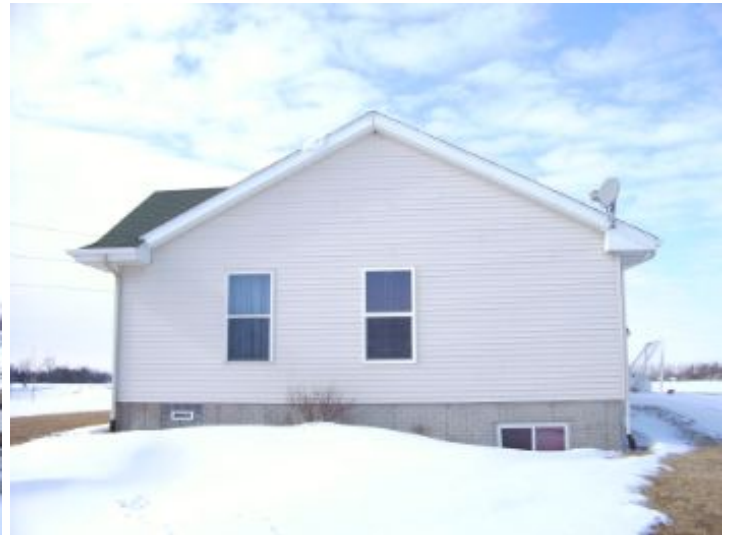
South Side of House

- Caulk and seal all gaps, cracks and openings.

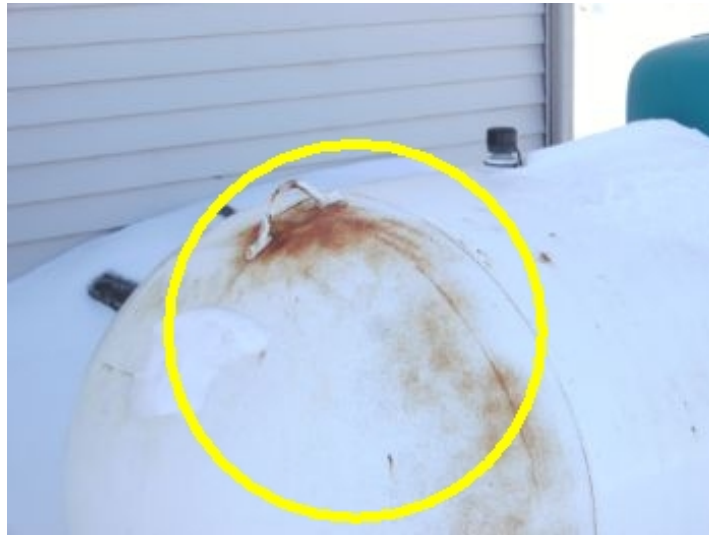
9. Main Gas Valve Condition

Materials: East side of garage - 1000 gallon tank  
 Observations:  
 • Tank showing sings of wear - recommend painting at earliest convenience

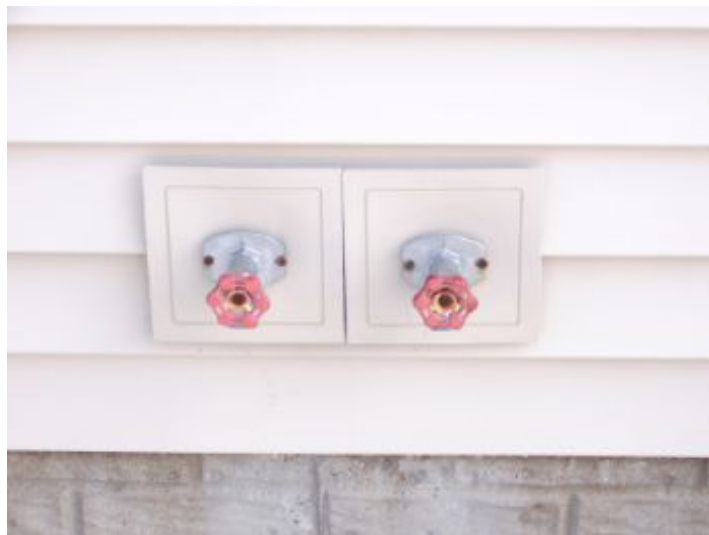
13. Exterior Faucet Condition

Location: North side of house.  
 Observations:  
 • Appears Functional.

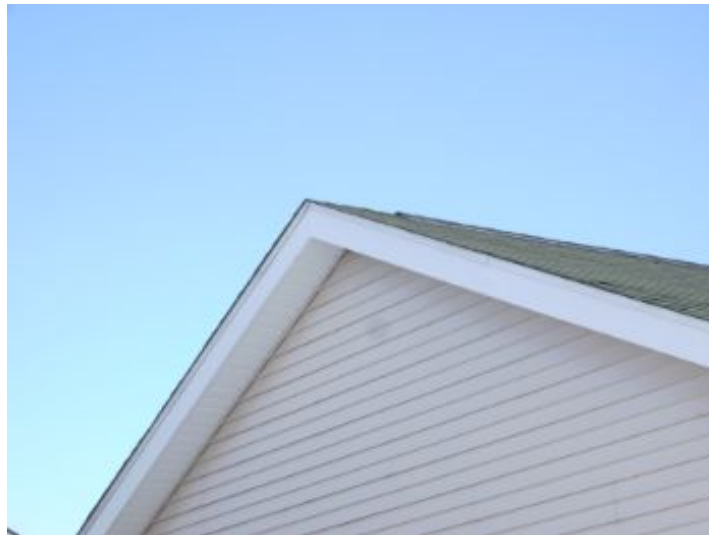
Ridge Vent Ventilation

- No major system safety or function concerns noted at time of inspection.
- Partially snow covered, not fully inspected.

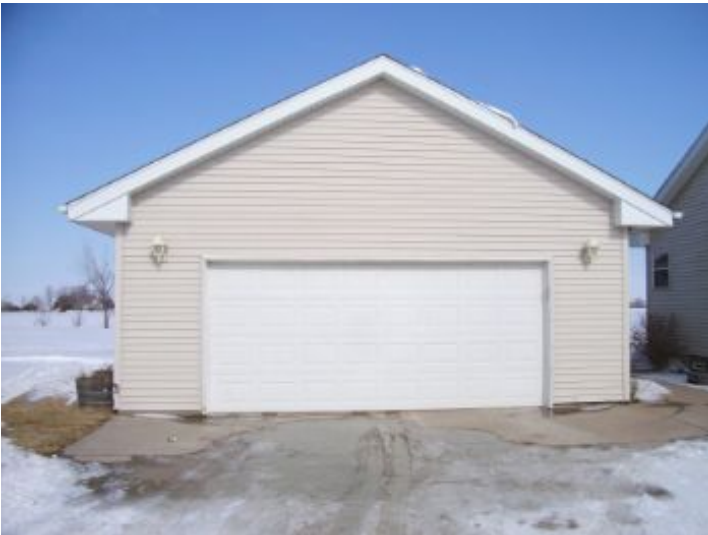
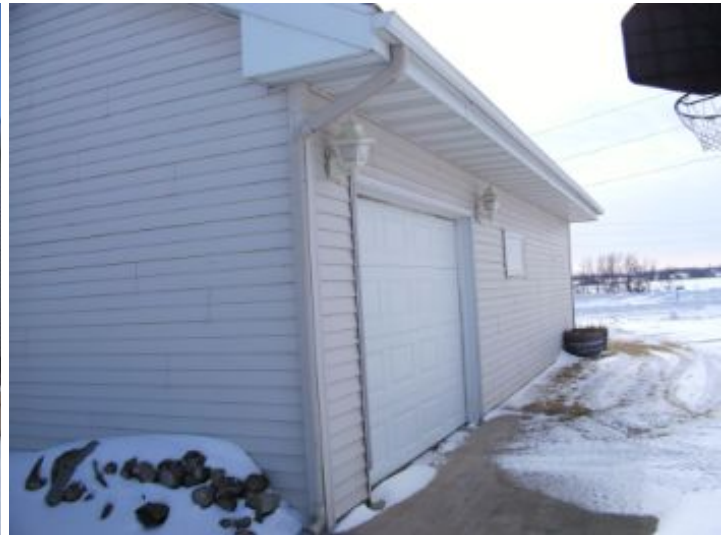
Observations:  
 • There are no firewalls present.  
 • personal items prevent complete inspection

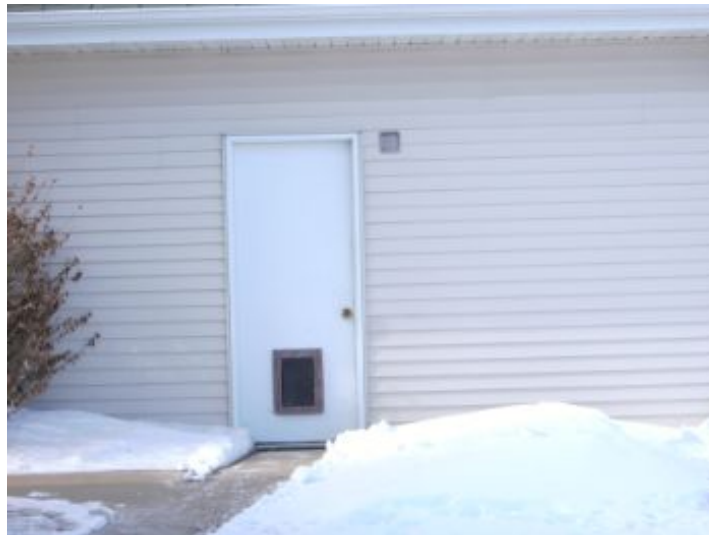
- There is a pet door present in the garage exterior door.

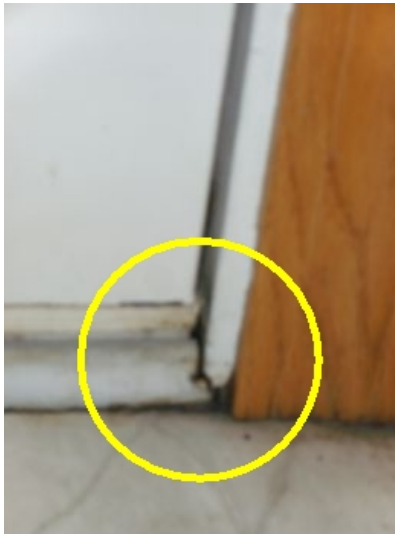
- Laundry room door going to outside does not latch properly, appears jamb is damaged - recommend qualified contractor inspect / repair

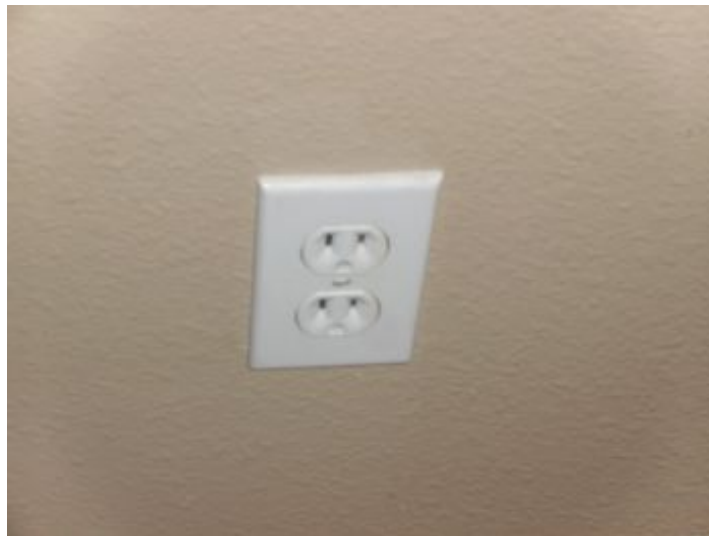
- Some outlets not accessible due to furniture and or stored personal items.
- Bedroom circuits are NOT protected by an arc fault circuit interrupter type breaker. An arc fault interrupter will shut itself off if it detects a short, thus preventing an electrical fire.

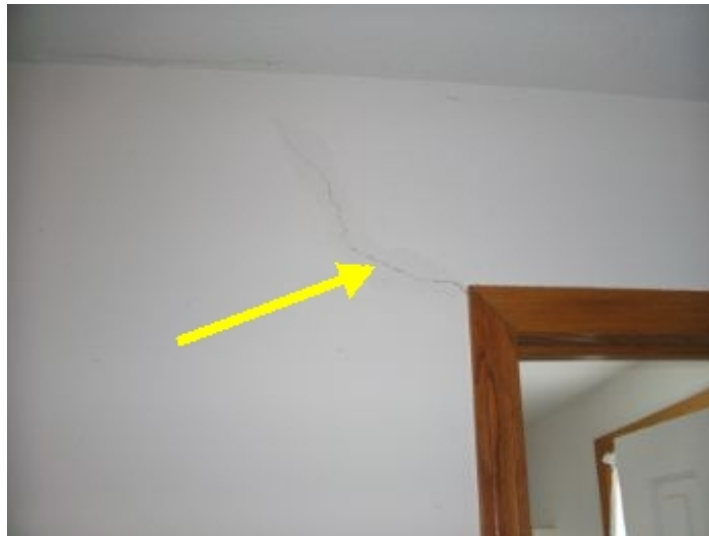
- Small crack on wall between bedroom and master bath - appears possible foundation settling - recommend qualified contractor to inspect and or repair

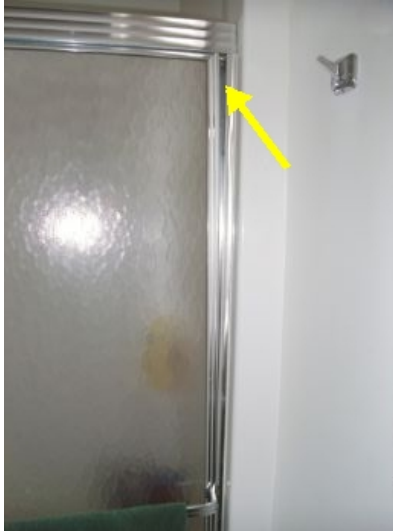
- functional
- Sliding door not properly aligned

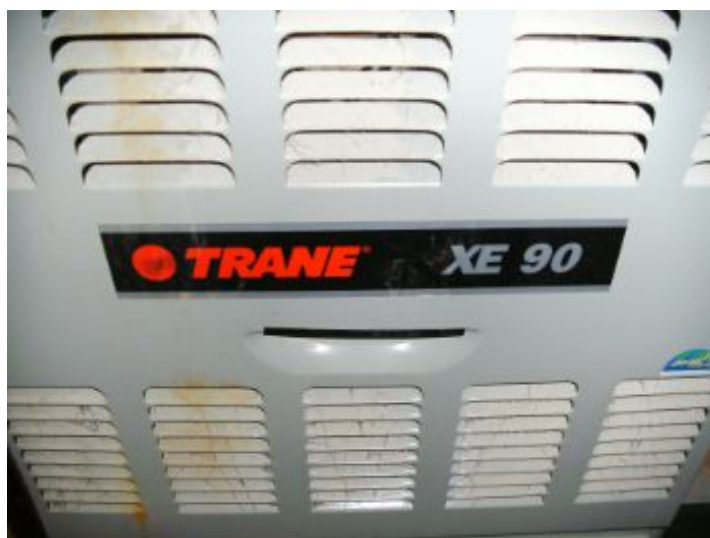
- Fuel Furnace: Last service date is over one year ago, or is unable to be determined. Although this unit appears to be operating properly from controls, there are areas which cannot be seen without specialized equipment and training. One such area is the combustion chamber / heat exchanger where cold air blows across the "fire box", becoming the hot air that circulates throughout your home. During the life span of any furnace, this metal wall may develop a crack or a broken weld, allowing carbon monoxide to circulate throughout the home. This is why furnace specialists recommend a complete inspection annually; consider having unit inspected by certified HVAC technician.

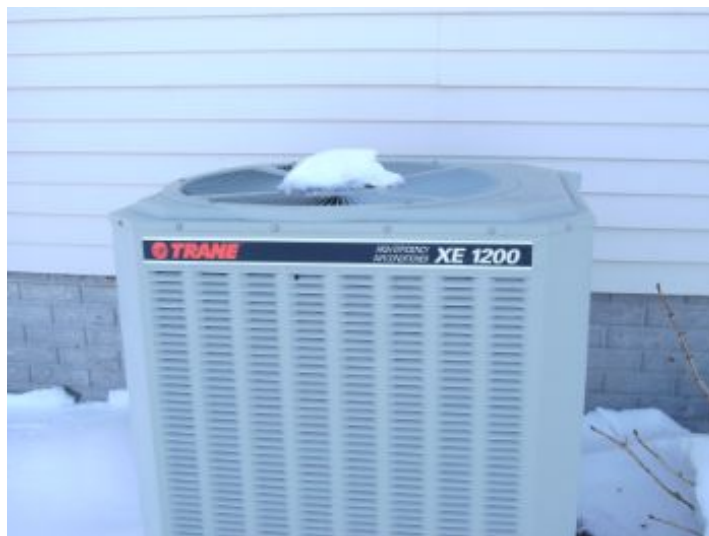
- Appeared functional at the time of inspection.
- Annual HVAC service contract is recommended.
- NOTE: Unit(s) not tested in the cooling mode. See Limitations.
- The data plate on the exterior cooling unit was not visible/legible at the time of the inspection.

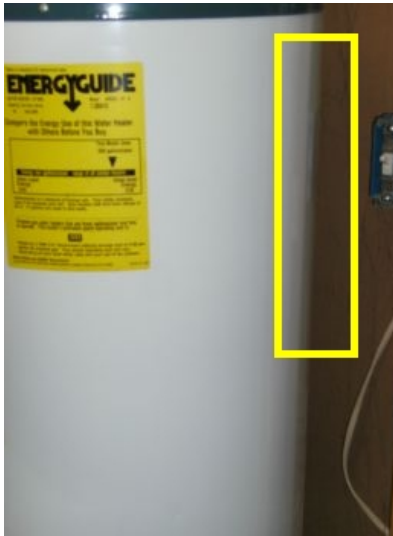
- The water heater is not strapped.

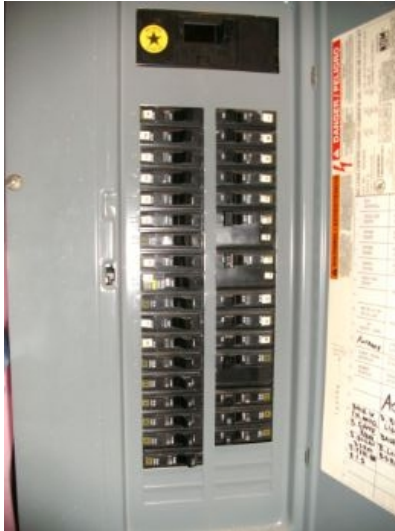
- No major system safety or function concerns noted at time of inspection at main panel box.

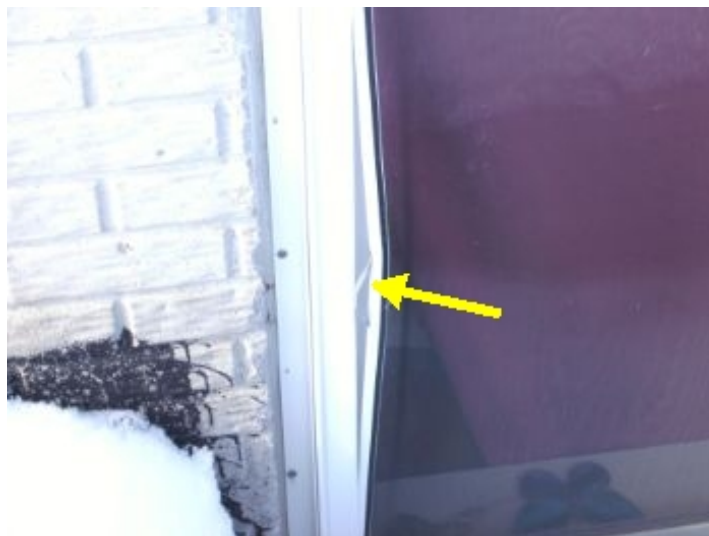
- Glass block windows with vents in basement.
- Operated windows appeared functional, at time of inspection
- **Egress window screen damaged**

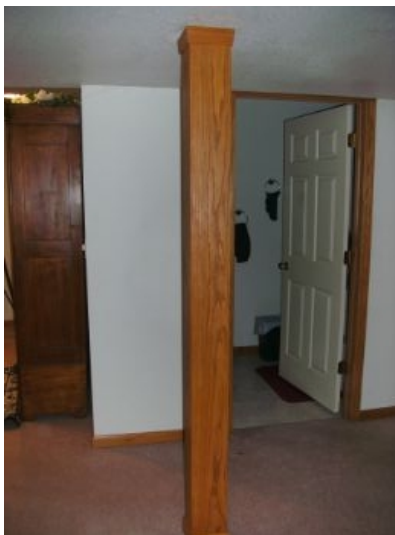
- No deficiencies were observed at the visible portions of the structural components of the home.
- Columns and beams are partially finished, unable to fully inspect.
